TOWER CRANE ACCIDENT PROFILE

**UKM
PAKARUNDING**

A STUDY ON IMPROVEMENT OF TOWER CRANE SAFETY MANAGEMENT IN THE CONSTRUCTION SECTOR

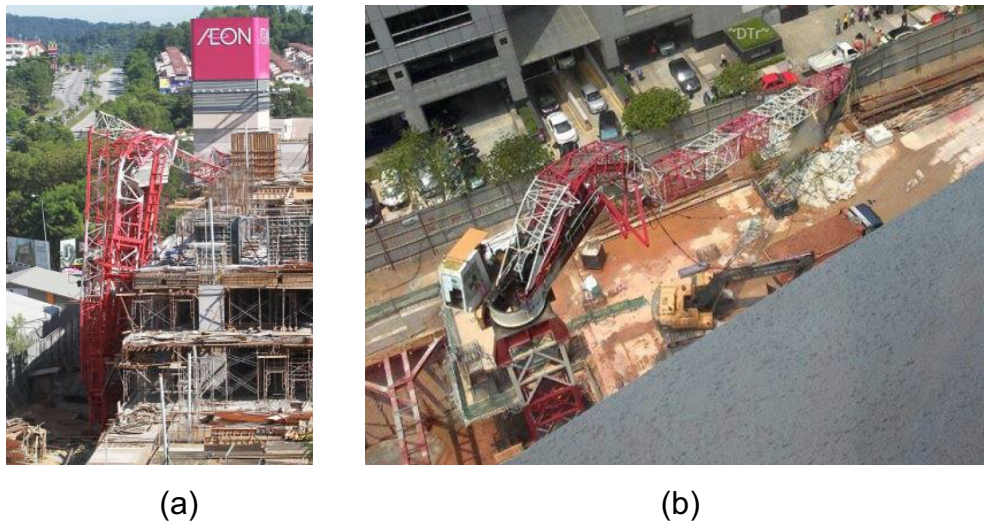
For year 2000, 2001, 2004 and 2007 the data on tower crane accidents can not be obtained. For example, an accident involving a collapsed crane in 2013 in Seri Kembangan was due to structural failure in the crane because of overloading, while the latest accident (April 2016) occurred at the Bangsar (detailed information are discussed in Chapter 5.4), caused by failure on the luffing angle limit switch. Detailed information regarding the accident in year 2016 will be discussed further in Chapter 5. In 2015 alone, 14 accidents were reported, and among the causes of the accidents were twisting of the tower crane's jib, snapping of the hoisting rod, detachment of the slewing unit of the crane and so on. Referring to the DOSH reports and the accidents that have

Figure 2.2 Occurrences of toppled crane in (a) Seri Kembangan, 2013 (<http://www.starproperty.my>) and (b) Bangsar, 2016 (<http://www.lipstiq.com>)

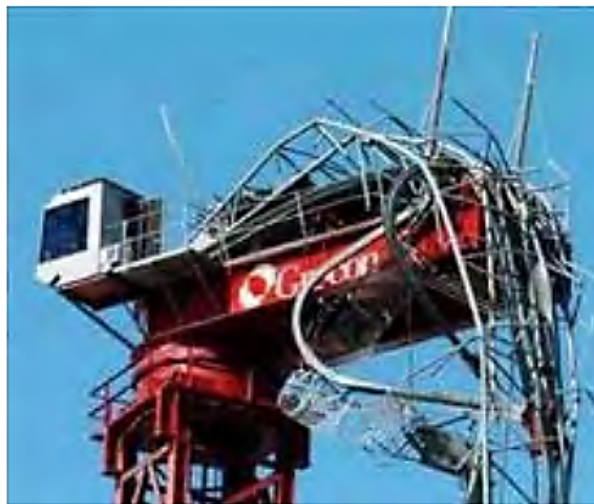
In Australia, only one case of an accident was mentioned in this report, i.e. in 2005 (Figure 2.8). However, the report on this case was very limited. This accident, which reportedly occurred on 3 February 2005, was caused by strong

winds, which caused the jib to collapse by folding. This report also mentioned that no further information was available about the case, especially about the angle of the jib when the incident occurred. This incident was categorised as an “Extreme Weather” factor.

Figure 2.8 Cases of crane accidents in Australia in 2005 (Isherwood, 2010)

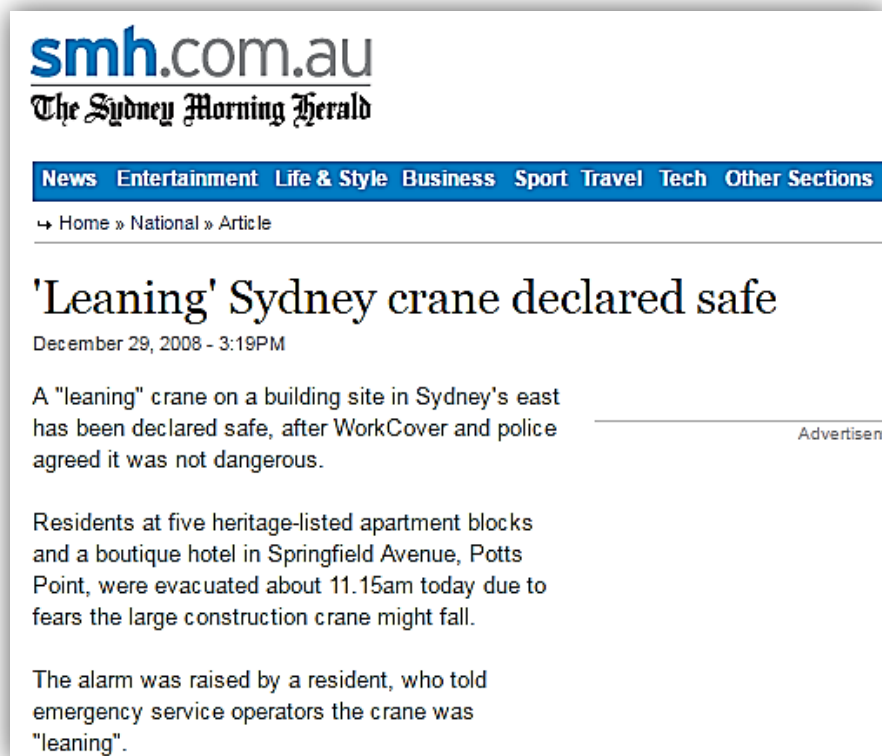
Sydney, Australia, which was reportedly in a poor condition at the construction site because of the unstable position of the counter-jib (leaning) that very likely caused the accident. This resulted in the temporary closure of the adjacent buildings, comprised of an apartment block and a hotel, due to concerns that the crane structure may fail and crush into the affected buildings. Due to this incident, a special investigation was carried out directly on the crane to ensure its level of safety and all operations were put on hold for a month to make way for a safety inspection. No accidents have been reported for this crane, except that the relevant authorities have to pay attention to the stable operation of the crane before any mishap occurs. This incident was also reported in The Sydney Morning Herald (Figure 2.9).

Figure 2.9 Online newspaper clipping (<http://www.smh.com.au/news>)

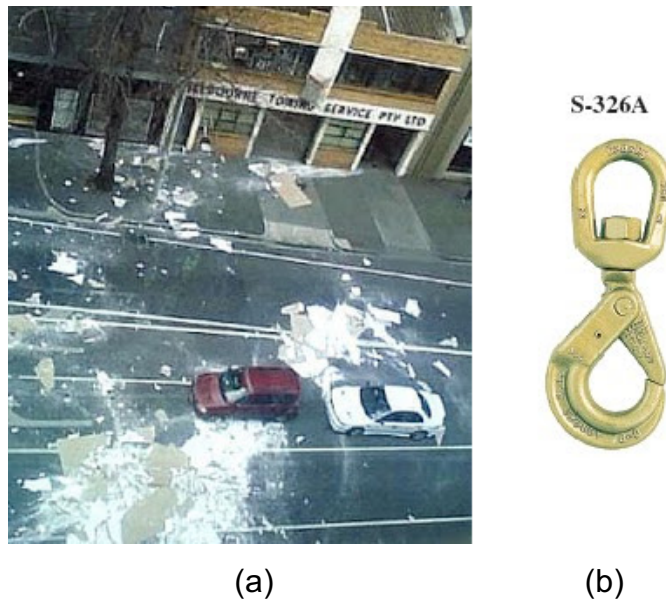
The incident in 2009 occurred in Melbourne, Australia, where the crane failed to lift a load and almost caused it to smash onto a car (Figure 2.10(a)). This article did not explain in detail how the incident occurred. Crane accidents are often caused by rigging failure, such as what happened in New York in 2007. In this case, it is important to ensure that the rig is appropriate for

carrying a certain load and meets the standards. In this incident, it was reported that the load was at a height of 180 feet when the accident occurred. It was also reported that this accident was due to error on the part of the workers at the construction site, who only changed the rig chain randomly, without specifically assessing whether the type of rig was appropriate for the load. This article also emphasised the aspects of supervision and in-depth knowledge on the maintenance and use of tower cranes.

Figure 2.10 News on accidents in Melbourne (a) accident incidents (b) rigs
(<http://towercraneaccidents.blogspot.my>)

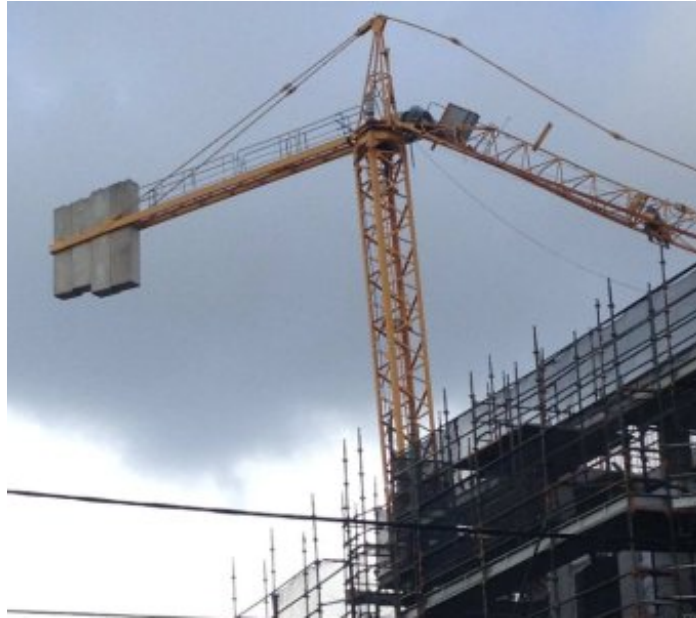
The Crane Accidents blog (<http://www.craneaccidents.com/tag/tower-crane/>) reported on an accident that occurred on 26 February 2016 in Hornsby, Sydney, Australia. The fire and rescue personnel reported that this incident was not caused by the wind. There was no detailed report on this incident. The picture of this crane failure is shown in Figure 2.11.

Figure 2.11 Crane accident in Hornsby, Sydney (<http://www.abc.net.au>)

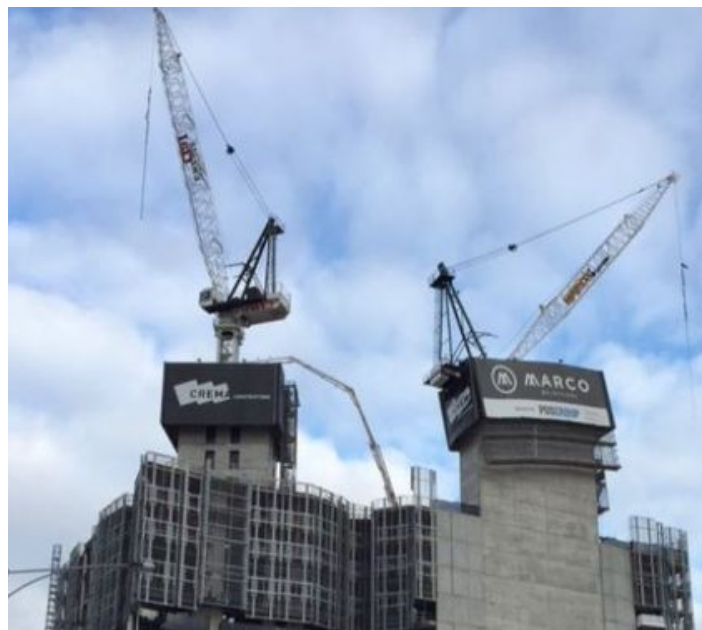
In August 2015, the luffing jib of a huge tower crane fell and crushed into the elevator shaft of a building in Melbourne, Australia as it was climbing up the tower (Figure 2.12). Local reports stated that the failure of the hydraulic jacking component caused the crane structure to fall.

Figure 2.12 Crane accident in Melbourne (<http://www.abc.net.au>)

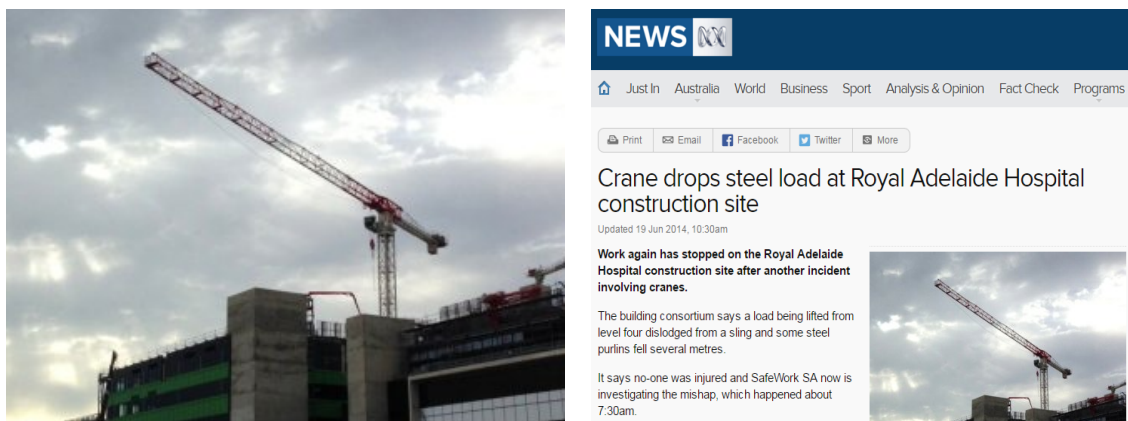
In June 2014, an incident involving crane failure occurred at the construction site of the Royal Adelaide Hospital in Adelaide, Australia. The load,

which was supposed to be raised from the fourth storey, fell from a height of 7 meters onto the concrete floor (Figure 2.13). Due to this incident, all cranes were stopped from operating to examine the question of safety. An unofficial statement from Construction Union slammed the construction consortium for this accident, claiming that this disaster occurred because the consortium took shortcuts to complete this project as it was reported that the project was behind the originally planned schedule.

Figure 2.13 Crane accident in Adelaide (<http://www.abc.net.au>)

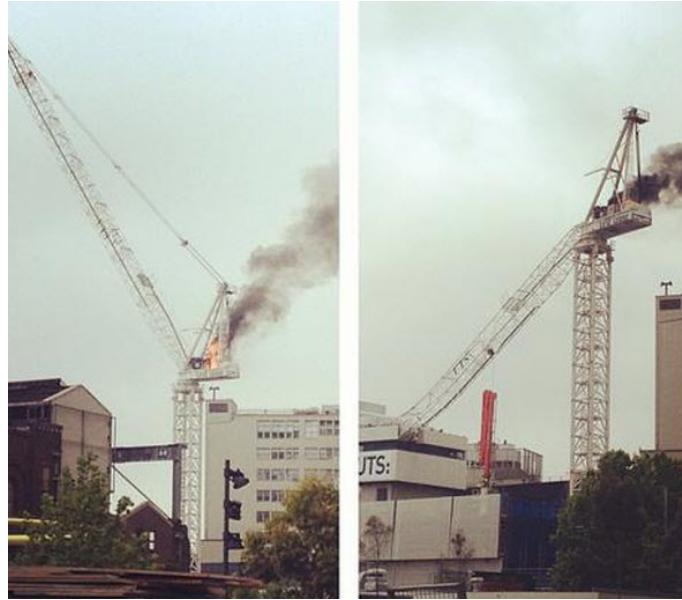
In June 2012, an accident involving a tower crane was reported at a construction site in Sydney's city centre (Figure 2.14). Witnesses saw the arm of the crane swaying before it broke and crushed into the roof of a building adjacent to the University of Technology Sydney. There were no fatalities. It was reported that this accident occurred when the cable supporting the boom caught fire and resulted in failure. WorkCover New South Wales conducted an investigation to determine the cause of this accident. However, they also criticised the construction company for failing to conduct the required maintenance.

Figure 2.14 Crane accident in Sydney City Centre (<http://www.sbs.com.au>)

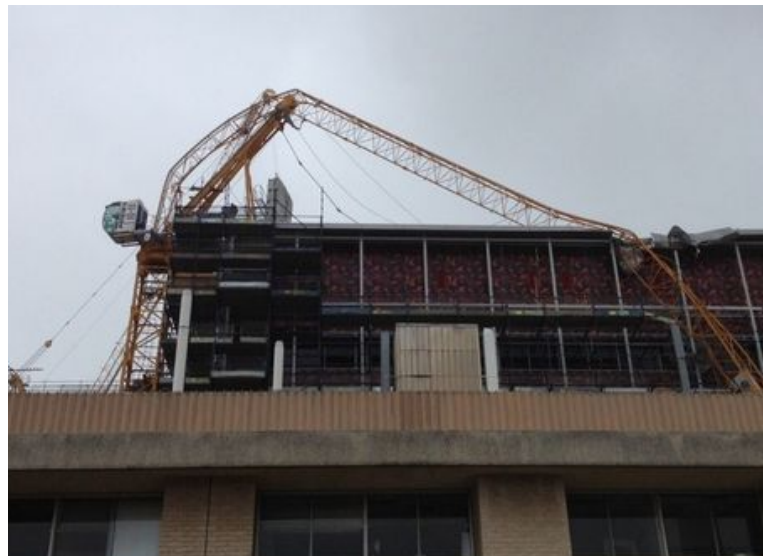
In June 2012, a crane accident occurred in Perth, Western Australia involving a luffing jib, which fell and crushed through the roof of a hospital. This incident was caused by strong winds blowing at a speed of 140 kph (Figure 2.15). Figure 2.16 shows the average number of crane accidents that occurred in Australia from 1999 until 2016.

Figure 2.15 Crane accident in Perth (<http://www.vertikal.net>)

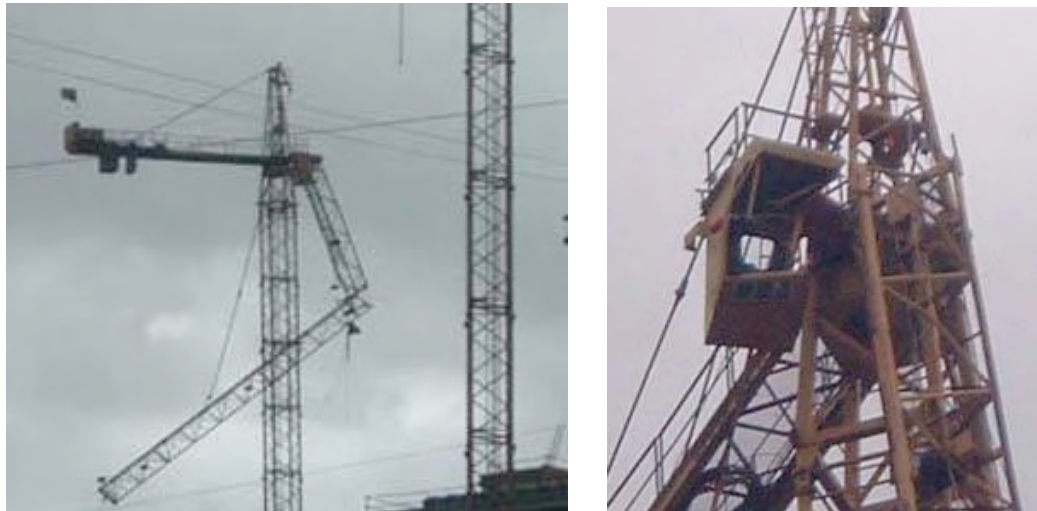
On 1 February 2004, the jib from a Wolff saddle jib crane failed in two sections, but was prevented from falling to the ground by the jib tie bar (Figure 2.18). It was reported that the incident was caused by strong winds, and the report mentioned that there was a possibility that motor brake slew had jammed or was left in a neglected state. This incident was categorised under extreme weather.

Figure 2.18 Incident of overturned tower crane in Dublin, Ireland
(<http://www.vertikal.net/en/news/story/741>)

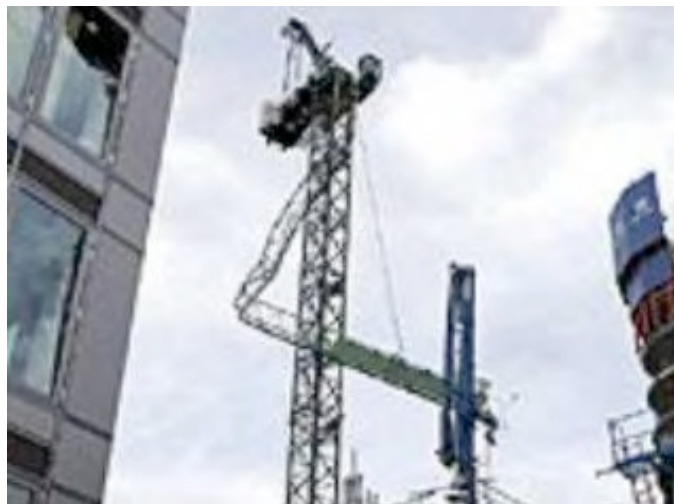
The jib of a luffing crane buckled and collapsed on 19 October 2006 (Figure 2.19). It is believed that the crane collided with another crane on the same site. This incident was categorised under Misuse.

Figure 2.19 Tower crane accidents in Holborn, London
(<http://www.vertikal.net/en/news/story/3122>)

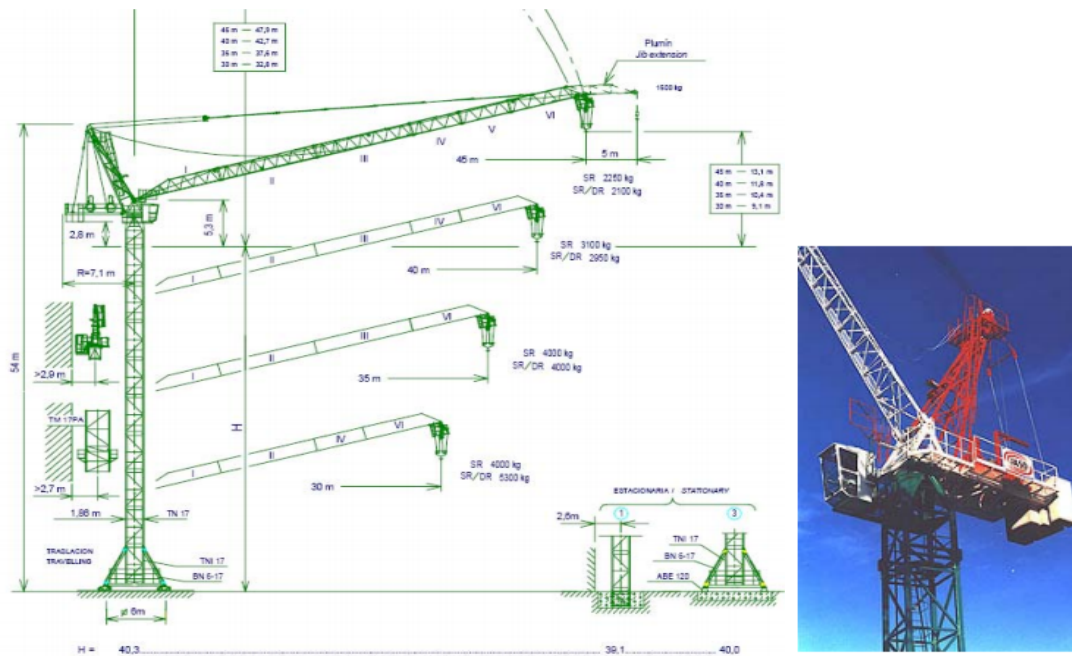
On 2 June 2007, a Terex Comedil tower crane, owned by Select, was being extended. The crane collapsed during the climbing operation on top of the Croydon Park Hotel. Subsequent investigations by the HSE revealed that the bolt connecting the climbing frame to the crane structure was loose or was not in use during the climb. The climbing crane was not bound to the structure and the mast broke, causing the crane to collapse. This incident was categorised under Erection/Dismantling/Extending.

Figure 2.20 Luffing jib crane involved together in accident (HSE Report 2007)

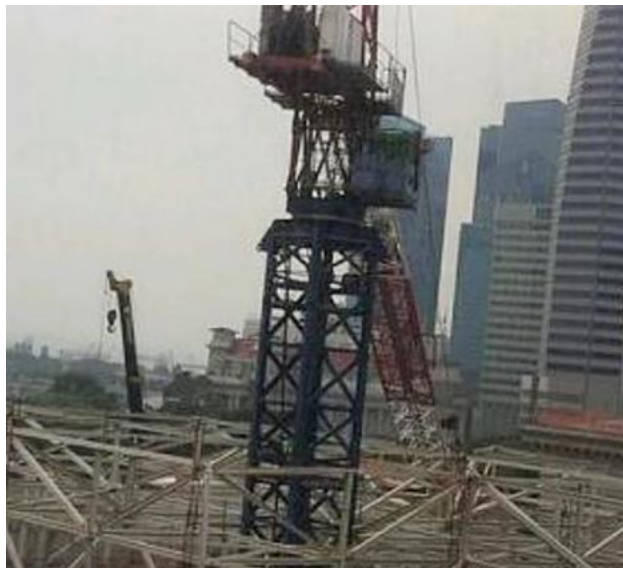
Figure 2.24 Cases of tower cranes collapsed in Singapore in 2013 (<http://www.vertikal.net/en/news/story/18420>)

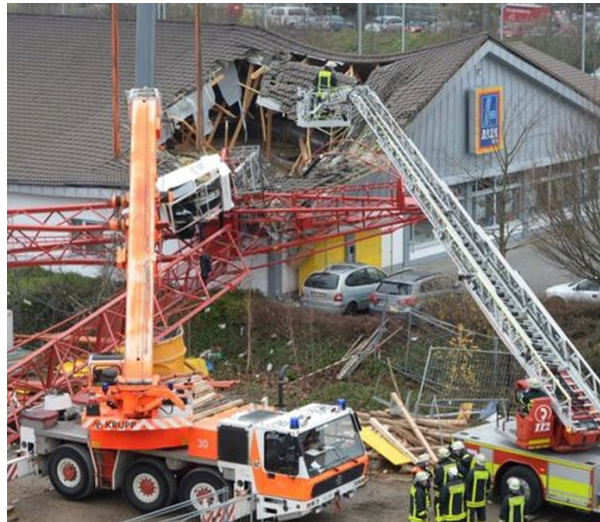
Figure 2.33 Collapse of tower crane at the Aldi supermarket in Homburg, Germany (<http://www.cbc.ca>)

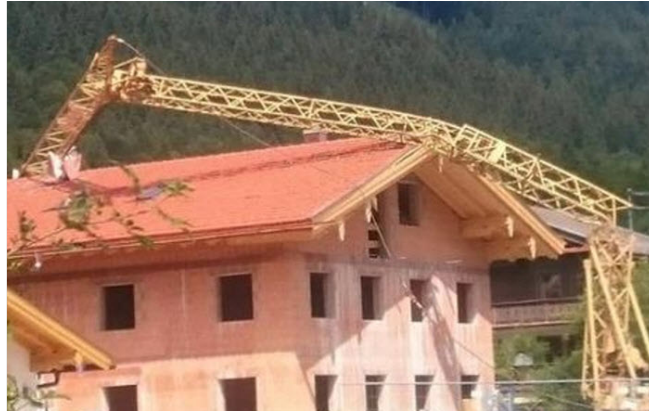
Figure 2.34 Tower crane accident in Bavaria due to metal fatigue failure at the jib support (<http://www.craneaccidents.com>)

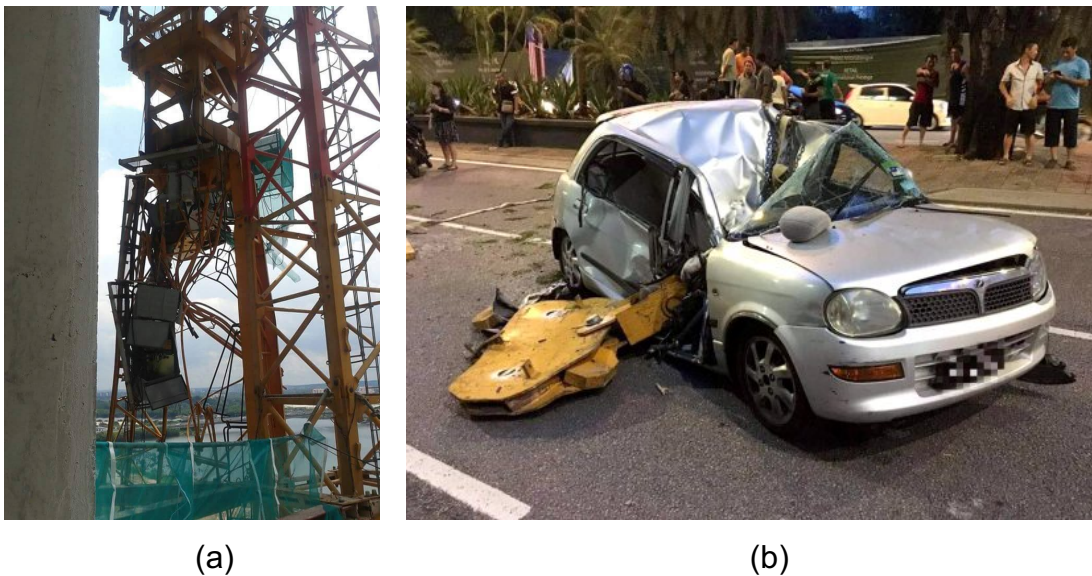
Figure 3.10 Crane accidents in (a) Johor (July 2016), and (b) Bukit Bintang, Kuala Lumpur (August 2016) (www.bh.com.my)

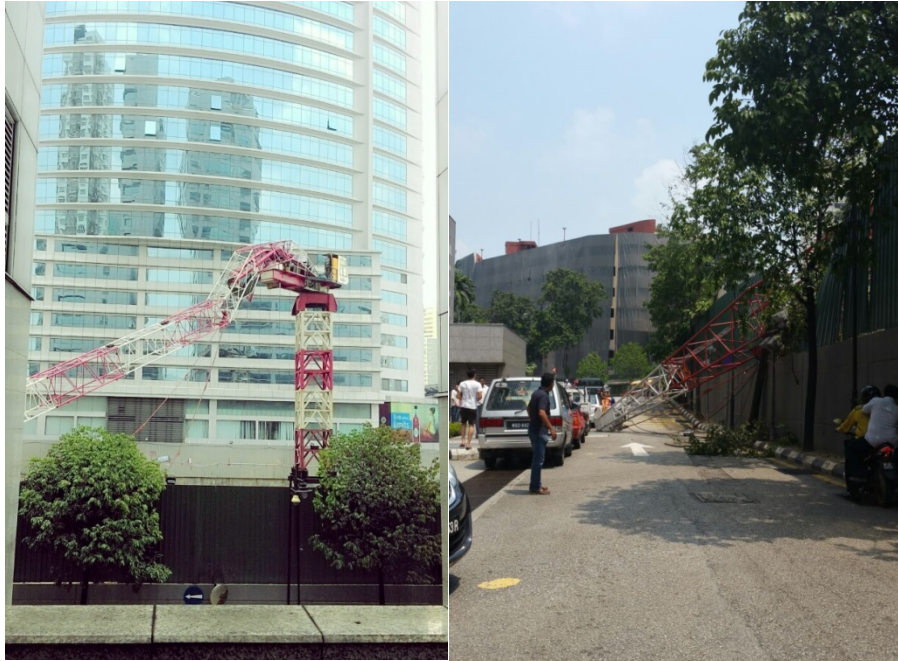
Figure 4.8 Situation of tower crane accident in Bangsar

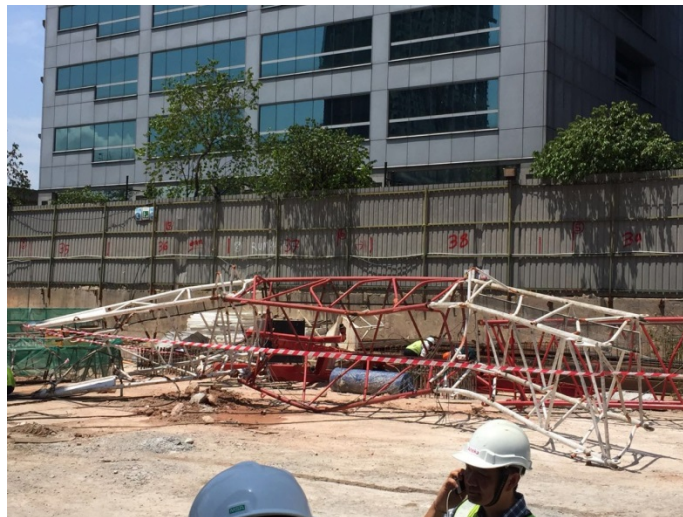
Figure 4.9 Frame of the crane that was dismantled at the construction site

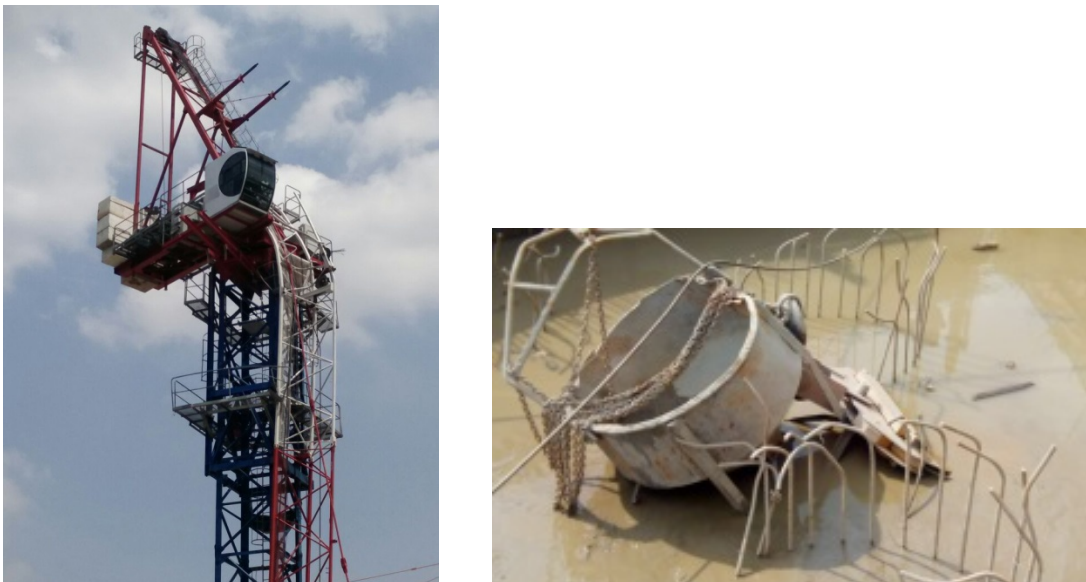
Figure 4.10 Failure of crane in Jelatek (a) The broken crane, (b) used bucket stuck on crag

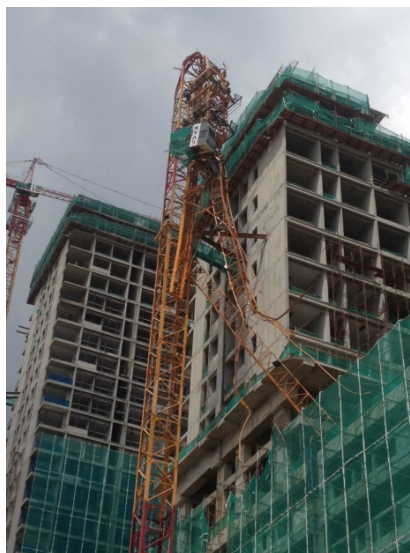
Figure 4.11 The snapped crane happen at Johor (2016)

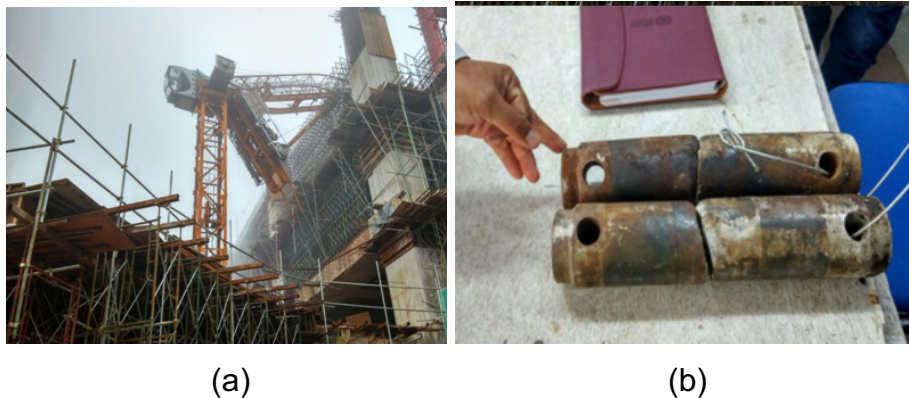
Figure 4.13 Failure of tower crane in Kuala Lumpur 2016 (a) Overluffing crane and (b) broken connection pin (<http://www.dosh.gov.my>)

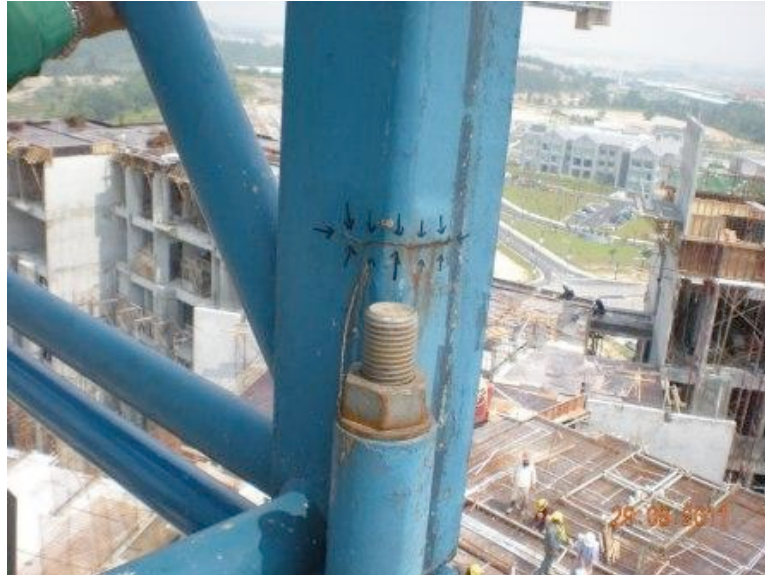
Figure 4.18 Hollow steel crane buffer
