SAFETY ALERT

JKKP/DOSH

ACCIDENT OF TOWER CRANE DUE TO STRONG WIND

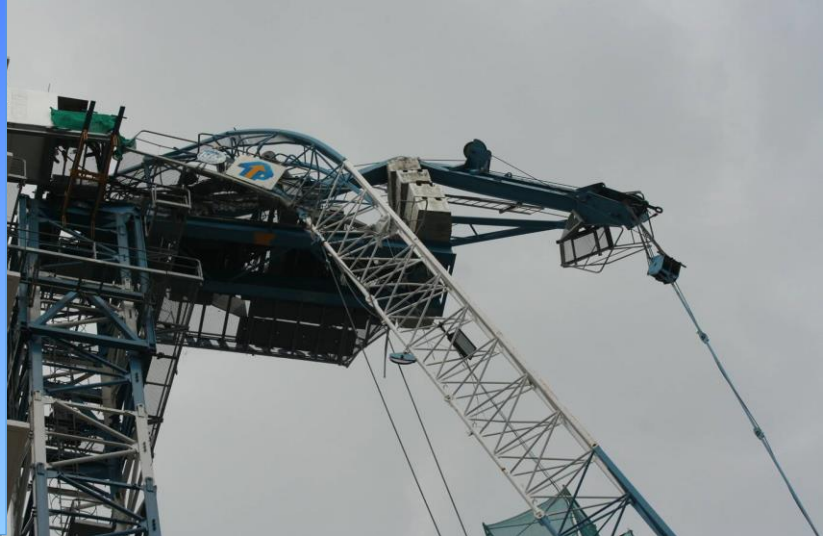
Recently, an accident had occurred involving parked tower crane. The incident occurred on Sunday due to strong winds when the crane was not in the operation. The investigations found the crane failed to slew during the strong wind and caused very high load on the boom structure and subsequently fell to the adjacent building. Hence, these steps should be followed to avoid the same occurrence:

- a) Owners and Competent Firm (FYK) shall ensure that the brake release mechanisms of the tower crane are checked, inspected and maintained in accordance to manufacturer manuals;

- b) Instructions and training shall be provided to crane operators and maintenance worker on proper inspection and maintenance methods;
- c) Responsible person (OYB) from Competent Firm shall ensure that crane operators and maintenance workers carry out their work according to manufacturer's manual where the tower crane is placed in a free state to slew when parked and not in operation;

- d) The crane operator shall ensure that the tower crane is parked at the appropriate radius and angle as specified by the crane manufacturer;
- e) Competent Firm shall conduct periodic inspection of the brake release mechanism whenever the crane is erected;

- f) Owners and Competent Firm shall ensure the latest information from the manufacturer related to adjusting and fixing the brake release mechanism.
