**ROOF STRUCTURES OF
VELODROM COLLAPSED IN NILAI,
NEGERI SEMBILAN**

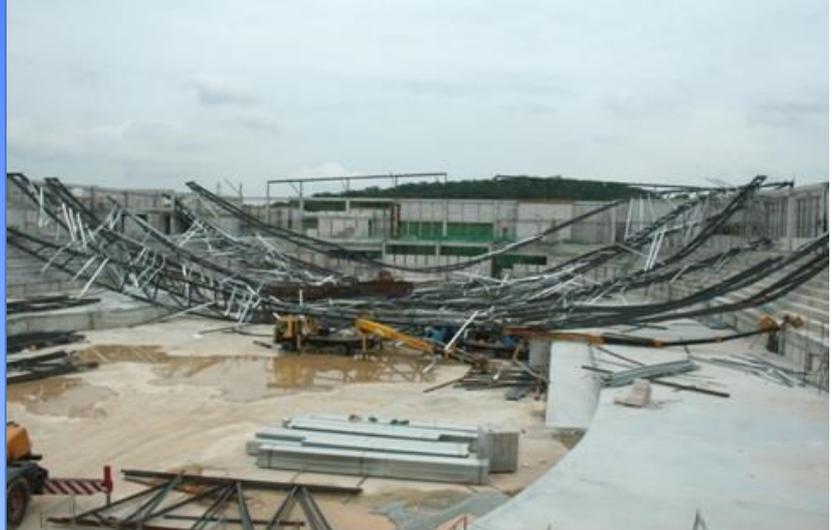
An incident involving the collapse of a roof truss structure which is in the process of installation in a velodrome has occurred at approximately 3:00 pm, June 18, 2016 in Nilai, N.Sembilan. Two skylift machinery under the roof structure has been crushed by the collapsed roof structure. The skylift machinery was used to lift workers to do the connection work on roof structure. This incident also caused a worker injured and no casualties occurred.

The root cause of the collapse of the roof trusses structure may be caused by several factors such as the following;

1. The failure of the design and installation of the roof structure, the support columns and girder structure.
2. The construction and installation of roof structures, column and girder structure is not in accordance with design specifications that have been made by the consultant and do not comply with the safe installation methods.

3. The construction materials used are substandard and not in accordance with design specifications.
4. The roof structure has suffered over-load , caused all columns or girders structure fail and collapse.

5. There was a failure on the girder structure which supports the roof truss structure.
6. There was a failure in the connection component of roof truss structures involved.

7. The truss roof structure was not supported by sufficient and strong support structures.
8. There is no effective communication between the parties involved such as designers, engineers, consultants, contractors and sub-contractors during the construction and installation of the roof structure.

1. The structure of the roof trusses built and installed must be stable, strong and serviceability.
2. The design of the roof truss structures must comply with the prescribed standards and codes. If there are any changes to the design, it must be referred to the designer for approval before installation is made.
3. The installation of roof truss structure must fully comply with the specifications and requirements of the approved design , and must also comply with safe operating procedure of structure installation. The installation of the structures shall be done by competent person.

4. Ensure that the material used for the installation of roof truss structure meets the prescribed specifications and standards.
5. Use and mounting of anchors bolt and its chemical for the connection of roof truss structure and girder to concrete column must comply to manufacturer instruction and design specification. These instructions include the size and depth of holes drilled, installation procedures and timelines durable.

6. Temporary support and bracing with adequate strength and stability shall be provided on roof truss structure.
7. Inspection and supervision on a regular basis from time to time should be done by a competent person during the installation of roof trusses structure ,it is to ensure that the installation work is done properly and completely and in accordance with the construction procedures that have been set. In addition it also to ensure that the structure is safe , stable and strong.

8. Enforcement use of checklists relating to the relevant authorities such as the request for inspection (RFI) is important to ensure that any subsequent job is safe to run.

9. HIRARC must be done before the installation of the roof structure.
10. Duty holders should monitor the structures under their management and control for adequate stability to ensure employees and members of the public are not put at risk from structural collapse.
