**SAFETY ALERT**

**JKKP/DOSH**

**WORKER INJURED AFTER  
BEING STRUCK BY A  
DETACHED HATCH COVER  
OF CEMENT TANKER**

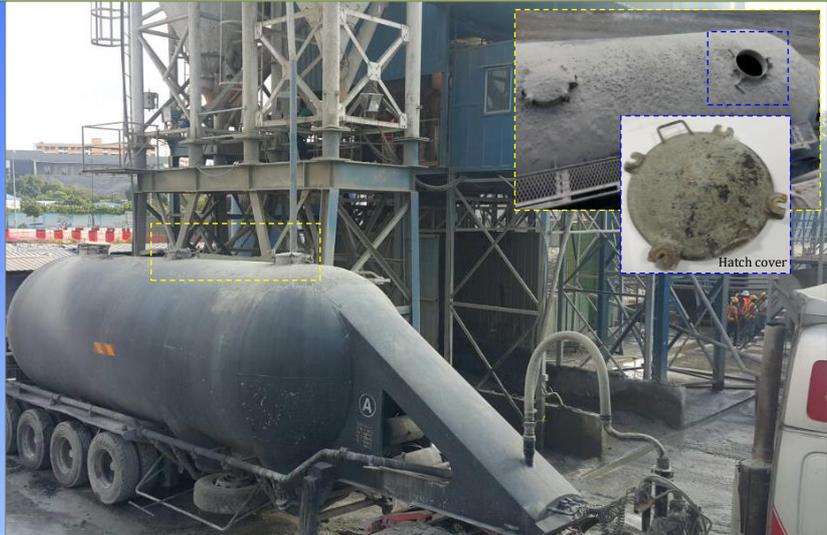
A cement tanker driver/operator sustain injury after one of the hatch covers positioned on top of the tanker detached and struck him. The impact pushed him down from the tanker. Shortly before the incident, the victim was doing some adjustment at the respective hatch cover.

The accident happened during the discharging operation of cement from cement tanker to silo was in progress. During this operation, the cement was transported into the silo via air-flow supplied to the bottom of the tanker (pressure of approximately 25 psi) by the air compressor unit mounted on the tanker.

- ensure safe working procedure for cement discharging operation from tanker prepared and complied throughout the operation
- ensure hatch cover locking mechanism is in good condition and closed completely (per manufacturer specification) before the cement discharging operation started - fit and secure locking pin
- carry out periodical inspection to the hatch cover and other components in accordance with manufacturers recommendations
- carry out remedial work and replace damaged component of the hatch cover (e.g. rubber packing) immediately
