**SAFETY ALERT**

**JKKP/DOSH**

**FAILURE ON WELDING JOINTS OF  
CRAWLER CRANE'S BOOM  
STRUCTURE**

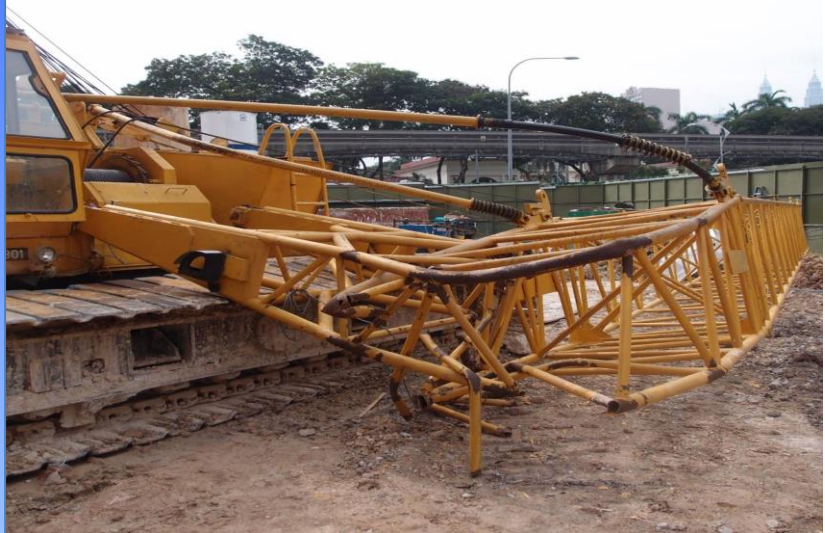
An accident involving a crawler crane had occurred during dredging activity for pile casing installation. The pile casing was installed using vibro-hammer that has been suspended on the main hook block. During the accident occurred, the crane operator has shifted the crane boom position from falling outside the construction area after it's started to fail. No casualty was reported from this accident.

- i. Thorough inspection on the crane's boom integrity include of its welded joint and others connection related to crawler crane's structure by conducting a Non-Destructive Testing (NDT).
- ii. Periodic inspection records on crawler crane shall be updated and audited from time to time by qualified person.
- iii. All the repairs work on crawler crane needs to be done by the firm and competent/qualified person.
- iv. Provide a training on design, operation, maintenance and inspection of crawler crane to the operator and competent person.
