TOWER CRANE ACCIDENT PROFILE

**UKM
PAKARUNDING**

A STUDY ON IMPROVEMENT OF TOWER CRANE SAFETY MANAGEMENT IN THE CONSTRUCTION SECTOR

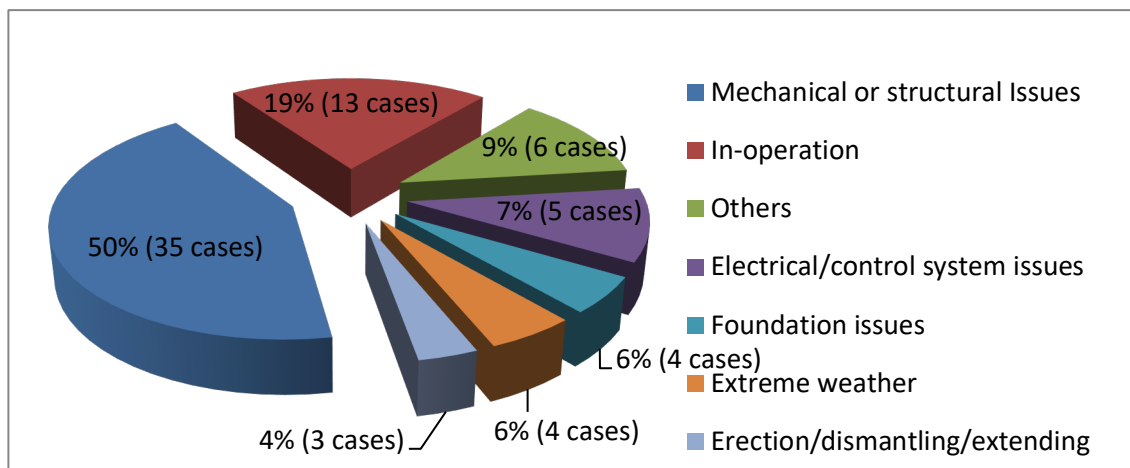
Figure 2.3 The percentage factors that cause accidents tower cranes (Abdullah & Wern 2010; Fail siasatan JKKP; <http://www.dosh.gov.my>)

Based on Figure 2.3, out of the 70 cases of crane accidents that occurred, 43% were due to mechanical or structural issues, namely, damage to the following components:

The second factor for crane accidents, 21% of which occurred during operations, was failure/negligence on the part of the crane operator, signalman, management and so on. The third factor was electrical issues or control systems, namely, 10%, which was caused by failure of the control system of the crane such as the lifting limiter (3 cases), hoisting system (2 cases) and failure of the luffing system (1 case). In addition, among the other factors that contributed to crane accidents were the failure of the crane base, i.e. 5% (3 cases), while 4% (2 cases) were due to the erection/mounting/dismantling of

tower cranes, 5% (3 cases) were due to extreme weather (wind and lightning), and 12% (7 cases) were due to other factors/unknown causes. Among the factors that influenced safety during the installation/dismantling of tower cranes (In Jae, 2015) were:

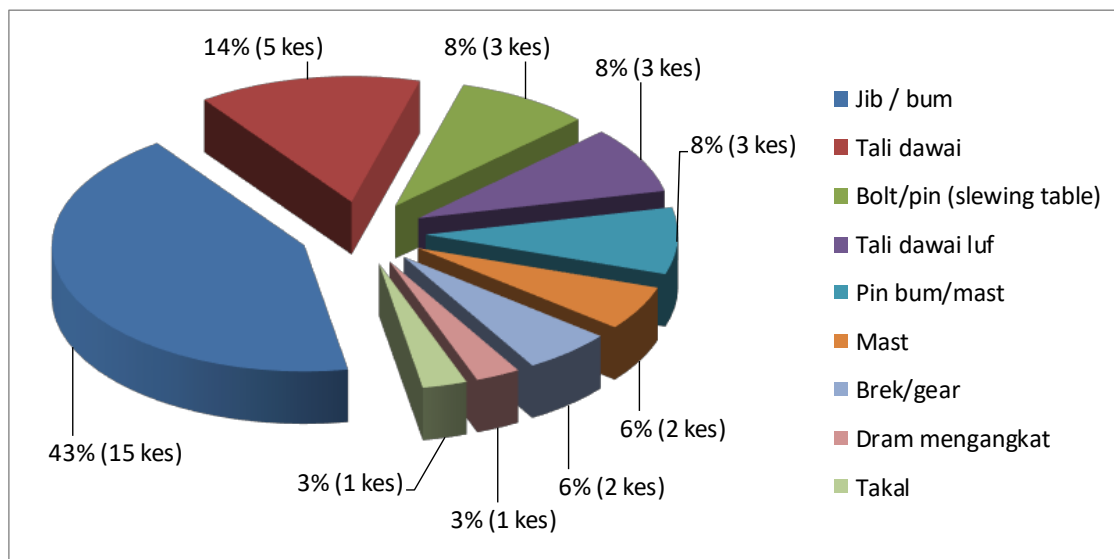
Figure 2.4 Components that fail during crane operation

- damage due to bent jib/boom
- snapped crane cable
- broken pin/bolt (slewing table)
- snapped luffing rope
- damage to the pin jib/boom
- problems with the gear/brakes
- problems with the hoisting drum
- snapped hoisting rope
- crane mast

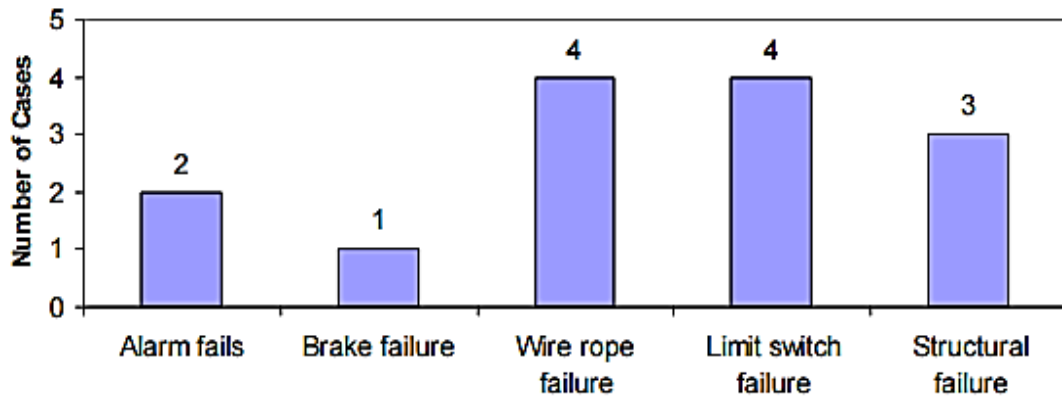
Figure 2.29 Types of component failures that contributed to crane accidents
(Crane Safety Analysis and Recommendation Report 2009)

The Management factor was the biggest factor contributing to the collapse of cranes, i.e. 25 cases out of the 40 cases that were investigated. Figure 2.27 shows the breakdown of the causes or the improper management system that has contributed to crane accidents, among them being a lack of supervised monitoring, non-compliance with crane operation procedures and not ensuring safety in the workplace. The Man factor accounted for 23 cases of violations of regulations and acts, lack of knowledge and human error, as shown in Figure 2.28. Figure 2.29 shows the types of component failures that contributed to crane accidents, among them being alarms, brakes, wire ropes, alarm switches and crane structures.

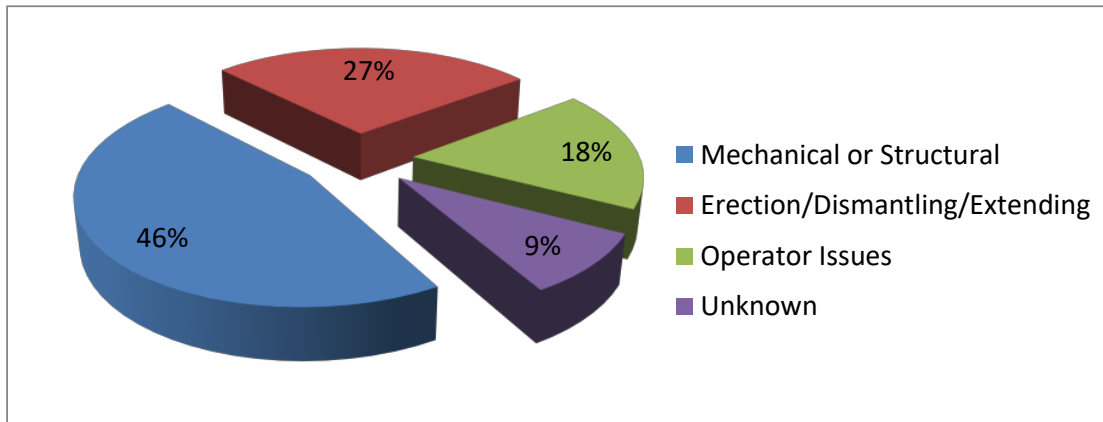
Figure 2.31 Causes of tower crane failures resulting in accidents in the construction sector

Figure 2.31 shows the four main categories contributing to tower crane accidents in Germany, namely the operation of tower cranes (building, opening and extending) (27%), mechanical and structural failures (46%), errors in the handling of operations by the operator (18%), and others due to unknown causes (9%). With reference to this analysis, it was found that mechanical and structural failures in tower cranes contributed to the highest number of

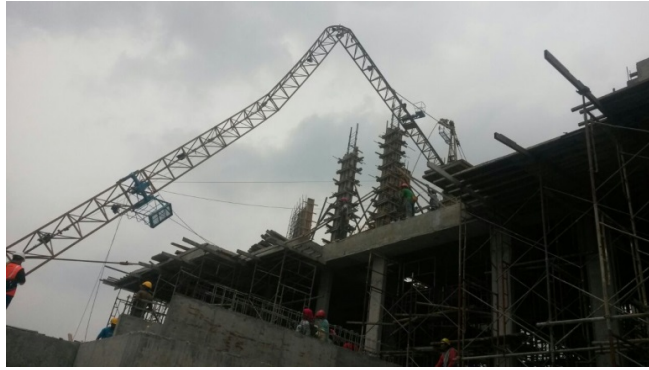
Figure 4.12 Bent crane boom

In this accident, the boom of the crane bent (Figure 4.12), but there were no fatalities. The used crane was purchased in Malaysia (repaired and serviced), and the mast structure, boom, slewing cable, swing ring, motor (original model) were first assembled at the site in January 2015. In the first test by DOSH in 1998, a load of 2100 kg was tested at 45 metres (radius). There were 2 operators (1 on standby) provided by the supply company. The operators had been trained at IKBN in Chembung (luffing crane course) and were operating a hammerhead crane. The operators had approximately one year of experience. The accident occurred when a load of iron weighing 900 kg was being lifted at a radial angle of 40 degrees (trolley positioned at 30-40 meters). Suddenly, the boom snapped and the load fell to the top floor of the building. The distance of the load from the floor was 4 feet. The maximum load was 3000 kg. The investigation into the cause of the accident is still on-going.

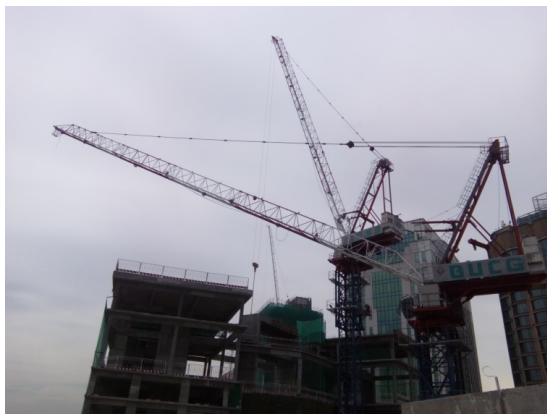
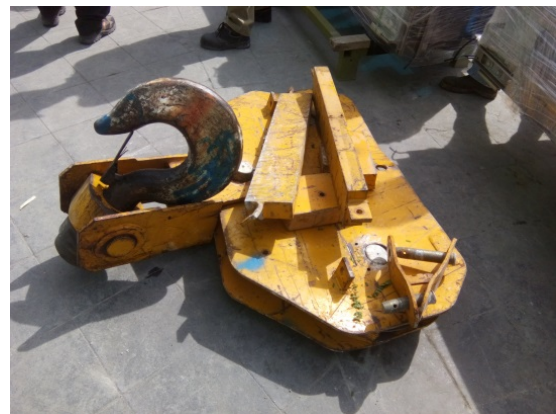
The crane model involved was a luffing STL230 model made in China. The iron hanger of the crane, which weighed more than 300 kg, fell onto the roof of a building (a height of more than 100 metres) and smashed into a car, causing the death of a woman (aged 24 years) (Figure 4.14). Bystanders claimed that they saw the iron hanger that was lifting a load snap, before falling and smashing into the victim's car. The position of the crane was also in violation of the rules of safety as it was operating beyond the radius of the fence at the construction site. The crane operator and the signalman could not be traced. The accident may have been caused by the pass at the lifting limiter, which lowered/raised the hook, causing the hook to be raised until it broke off at the tip of the boom, and caused the wire rope to snap. The cause of the accident is still being investigated. The case is being investigated under Section 304A of the Penal Code for causing death by negligence. The parties involved can be prosecuted under the Occupational Safety and Health Act 1994, and the Factories and Machinery Act 1967, which allows for a prison sentence of 2 years or a fine of up to RM250,000 or both (source: Mingguan Malaysia, 28 August 2016, and Metro, 26 August 2016).

Figure 4.14 Failure of tower crane in Bukit Bintang (a) Luffing crane STL230 model, (b) Iron hanger of crane which smashed into the vehicle

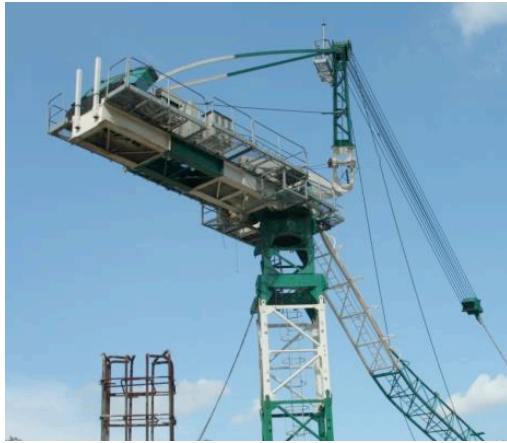
This accident involved a luffing crane that was operating in a residential high-rise building that was under construction in Kelana Jaya, Selangor on 27 April 2011, at 3.00 p.m. When the accident happened, the crane was not lifting any load. Figure 4.15 (a) shows the condition of the crane after the accident occurred, while Figure 4.15 (b) shows the same type of luffing crane under normal conditions. Checks at the site of the accident revealed that the 'A' frame and counter jig pendant had been severely damaged. Tests and analyses were carried out (Figure 4.16), and these were divided into four main stages, namely:

Figure 4.15 (a) Crane that experienced failure, and (b) position of 'A' frame and counter jib pendant in normal state

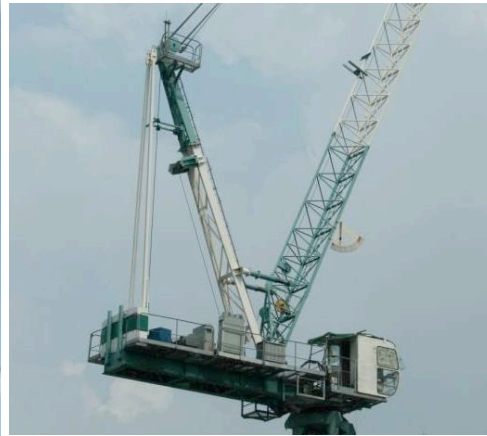
(b)

Based on the observations, it was found that there were severe cracks in the bent section of the counter jib frame. This was an indication that the welding that was done on that section had affected the structural strength of the frame. This is because the part that had been welded was fragile and was most vulnerable to rust. As for the damage to the counter jib pendant, it was probably due to overloading after the counter jib frame failed to function. Overloading at the pendant caused it to crack and fracture. Normally, the part that is the first to experience damage is the weakest part of the structure.

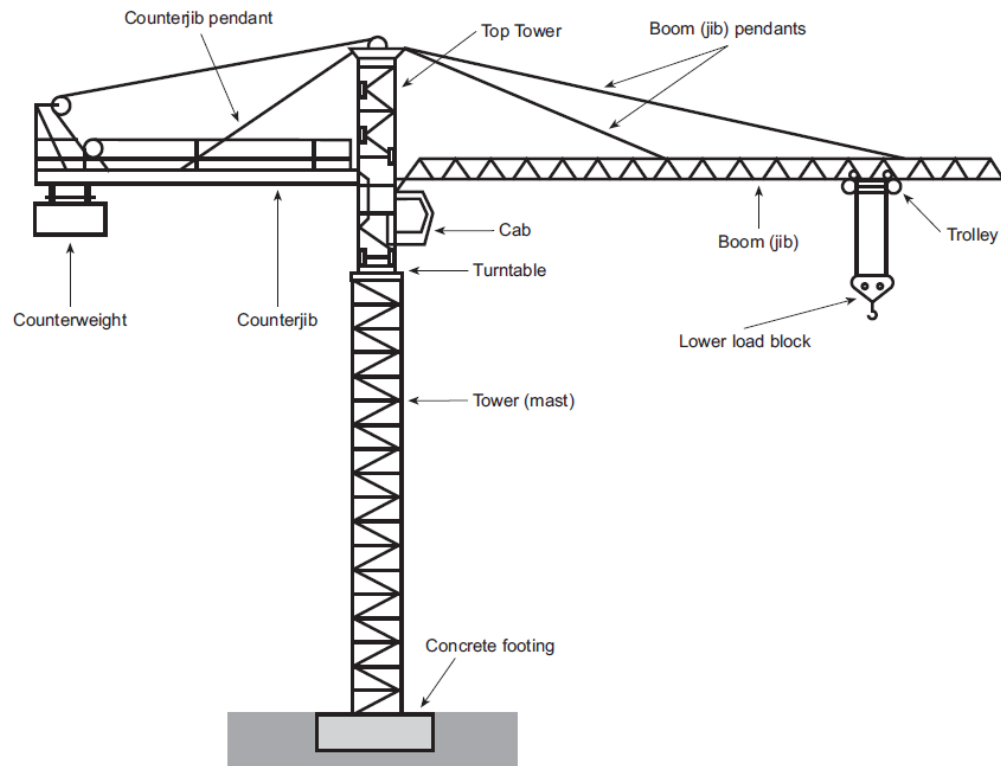
construction site in Johor Bahru on 21 November 2011 at 4:45 p.m. In that incident, the centre part of the tower crane jib (jib bottom) was said to have bent and fallen slowly when lifting a load of approximately 2 tonnes.

Figure 4.17 Schematic diagram of hammerhead tower crane
(Neitzel et al., 2001)

The results of the tests and analyses showed that there was a difference in the properties of the material taken from the perfect jib structure (not bent) and the material from the bent and rusted jib structure. This showed that the material/structure used when installing the tower crane was different, thereby giving a different structural strength. The different material/composition had a

high potential of contributing to the failure of the hammerhead tower crane that was involved in the accident.
