COLLAPSE OF PILING MACHINERY

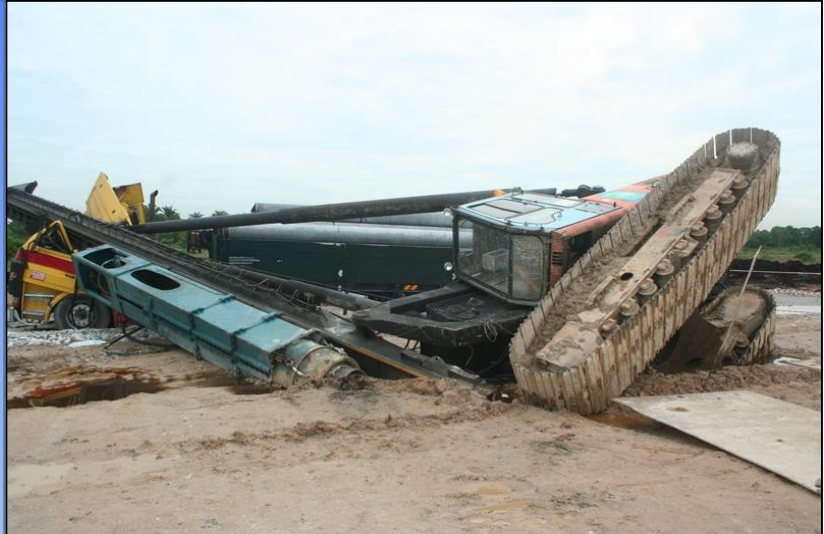
An accident involving a piling machinery occurred at a construction site recently. The piling machinery toppled while it was moving and had crashed a nearby truck. This incident resulted in severe damage to the prime mover of the truck and the lorry driver was injured in the head.

The contractor shall conduct HIRARC to identify all potential hazards that may arise from the work operation that will be carried out, and to take the necessary measures to prevent any unwanted incidents.

The contractor shall verify that the condition of the site where the work will be carried out is appropriate and safe, by conducting tests or with appropriate engineering calculations. For this case, the strength and stability of the soil that will accommodate the machinery load and work operation must be ensured.

Technical information related to machinery and work areas such as the bearing pressure, workload, machinery to be used as well as its working platform, and method statement should be known and made available before the work is carried out.

The operator shall operate the machinery with proper methods, and comply with work methods or procedures established in the operations manual.
