JKKP/DOSH

SAFETY ALERT EXPLOSION OF A STERILIZER

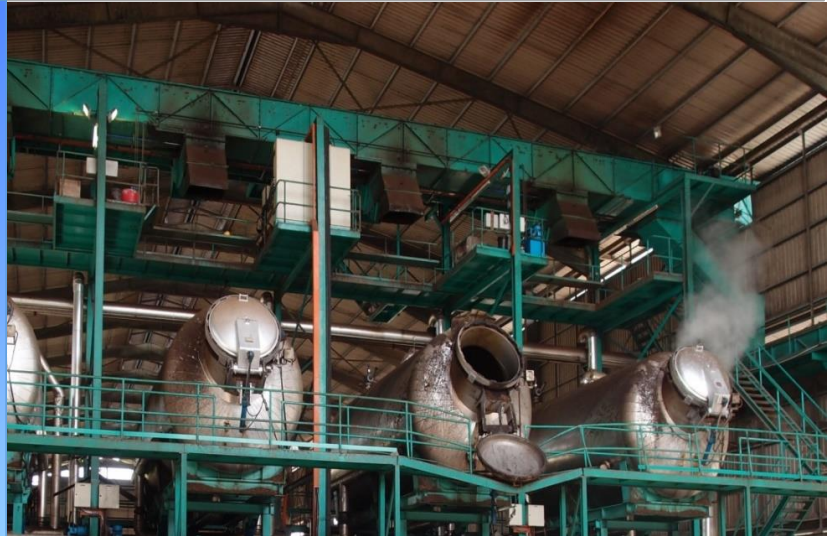
An explosion occurred in the sterilizer causing the inlet quick opening door in the sterilizer forced open around 12.30 pm. A complete cycle of a fresh fruit bunches (FFB) cooking process occurs at 42 psi steam pressure for 50-52 minutes. During the event, the sterilizer unit was found to explode at 30 psi steam pressure resulting the inlet quick opening door of the sterilizer forced open from inside. The contents were thrown out and caused damage to the part of the building's wall structure.

- i. Sterilizer inspection and operation need to emphasized consists of diameter of door, lock ring and other components with pressure must be monitored.
- ii. Periodic maintenance record must be updated and audited.
- iii. Ensure during inspection there is no defect at the quick opening door, integrity of the weld joints and lock ring.
- iv. Ensure that insulation completely intact to prevent the sensor damaged
- v. Design calculation need to improved to ensure the tolerance of door and lock ring should follow the specification and recommendation from the manufacturer.
