**SAFETY ALERT**

**JKKP/DOSH**

## **TOWER CRANE FAILURE**

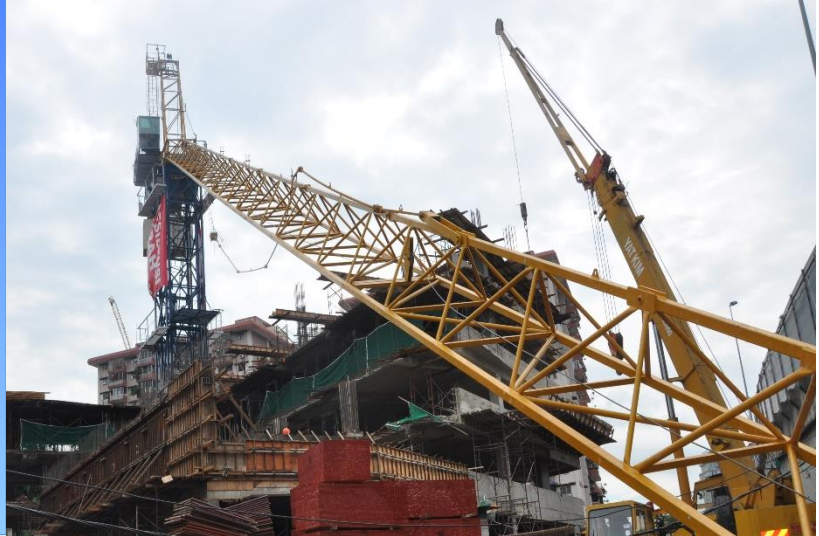
A dangerous occurrence has occurred involving a luffing tower crane that was in parking position where the boom has fallen slowly over a civilian car. Fortunately, this incident did not involve loss of life only property damage. On the day of the incident, wood lifting work was carried out in the morning but the crane operation was stopped after the crane operator detect a burned smell at the brake system. After the crane operation stopped, about an hour later, the crane boom dropped slowly until it hit a car. Preliminary investigation found that there was a failure in the crane brake system.

- i) Crane operators should handle the cranes in the appropriate manner and comply with the procedures set out in the operating manual;
- ii) Crane owners should ensure that cranes are maintained and checked periodically;
- iii) Inspection on brake components should be carried out carefully. Among brake components that need attention are as follows:-
  - a. Brake lining
  - b. Hydraulic oil supply
  - c. electrical wiring or components related to the braking system and other
- iv) If cranes were stopped within a short period of time, crane operators must comply with the procedure 'leaving unattended cranes' by ensuring :-
  - a. load has been removed from the hook;
  - b. Electrical supply have been switched off;
  - c. Brake locking should be put on and;
  - d. Boom should be parked according to the angle outlined in manufacturer's manual
